COMPRESSION PRESS BOLTS FAILURE ANALYSIS

Abstract: *This paper is focused on bolts failure analysis of a compression press. 8 bolts were used to attach the high speed cylinder cap to the upper ram cylinder of a hydraulic press used to produce forging parts. The bolts had been in service less than one year. Six (6) broken bolts out of eight (8) were submitted for failure analysis. One of the most common failure mechanism for bolts is fatigue. Fatigue cracks initiate and propagate in regions where the strain is most severe. Most fatigue cracks initiate and grow from structural defects. The manner through which the crack propagates through the material gives great insight into the mode of fracture.*

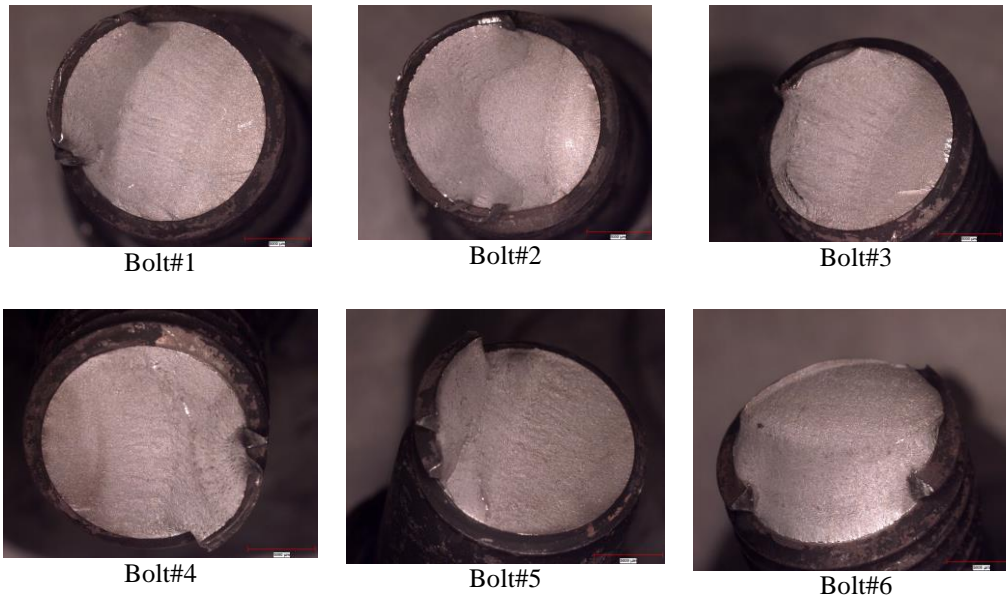
Figure 1 Macroscopic aspects of fracture surfaces, 6.7X

number starting with 1 to 6. All bolts present typical fatigue failure aspects (Fig.1), except bolt # 5 which presents ductile fracture. The Table 1 presents the calculated surface of fatigue fracture area and the position of fracture initiation for each bolt. There is no bolt to present fracture at the head/shank radius.

Bolt #	Fatigue fracture surface, %	Position of fracture initiation (thread #)	Bolt #	Fatigue fracture surface, %	Position of fracture initiation (thread #)
1	51.5	5	4	17.00	5
2	41.70	5	5	11.50	1
3	22.8	5	6	54.00	5

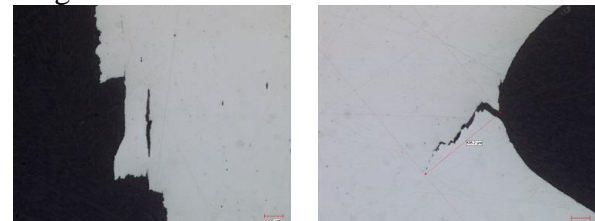
a) B5, Core crack aspect, 50X b) B5, Crack at root, 50X

Figure 2 Aspect of crack and the place where the picture was taken in bolt#5

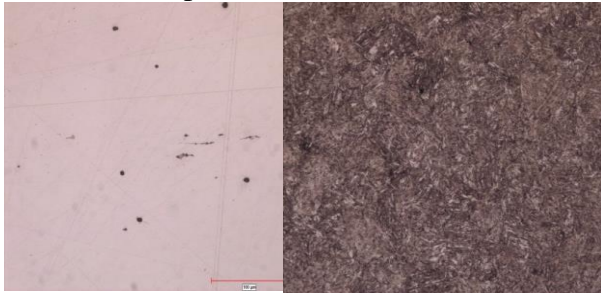
Figure 3 Non-metallic inclusions on longitudinal section of bolt #1, 200X

Metallographic longitudinal sections through the fatigue fracture origin were prepared for examination. Etched and un-etched microstructures were studied (Fig. 3 and Fig. 4), but no differences were noticed. Etched microstructure of unused bolt (#7, new bolt) on the core is showed in Fig. 4. No significant flaws were seen under the microscope in the regions of crack initiation. This indicates that the fatigue crack initiation was due mainly to stress factors.

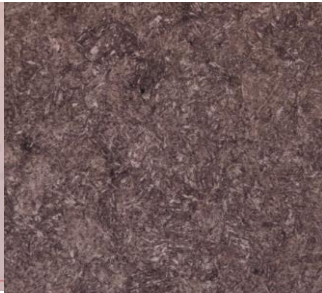
Figure 4. Etched microstructure of bolt #7 on the core, 200X

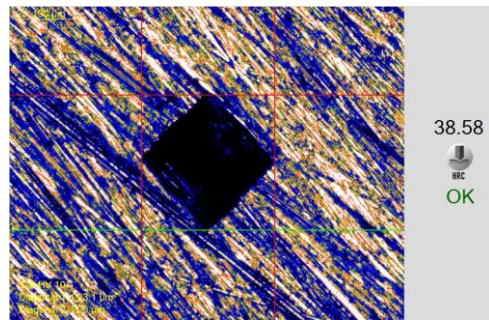
Correlating the results for microstructure, hardness and carbon content the producer used an alloy steel quenched and tempered. Material hardness (HRC) was tested (Fig. 5) on cross section mounted and polished sample. The average of obtained results was found to be 38.63.

Figure 5 Hardness indentation
