IN SITU STUDY OF THE DAMAGE EVOLUTION OF A ROLLING LINE CONTACT UNDER HEAVY LOAD

B.D. Onofrei, I. Muscă

*Faculty of Mechanical, Mechatronic and Management,
University "Stefan cel Mare", Suceava, Romania*

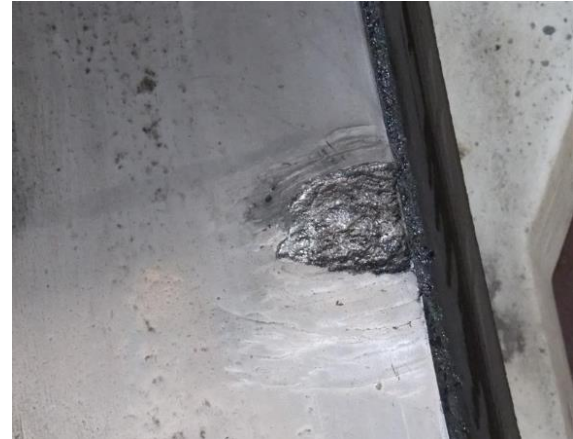
Figure 2 Damage of the ring

After 4 years in use at a routine maintenance check on the contact surface of the ring could be observed some wear defects, especially fretting and fatigue. After an additional time some material loss and small cracks could be seen which finally led to a total failure of the big ring by crack on the entire section. All stages of damage and defects development occurred in a short period of time of about 8 weeks.

First observation made in situ was regarding the material loss from the ring surface cracks and crushed areas, Fig. 2 which lead to possible explanation about contact fatigue.

High values of the hardness in section 5 could be explained by the plastic deformations present around area where material was lost.

Due to a high level cost of the ring replacement, firstly, a ring repair action was done by milling a 8 mm thickness from the external ring diameter of the active contact surface. Adjustments for the rollers supports also were made to ensure a correct dryer position and an uniform contact between bodies. Finally the crack propagation thru entire section occurred after an additional time of 5 weeks of using.

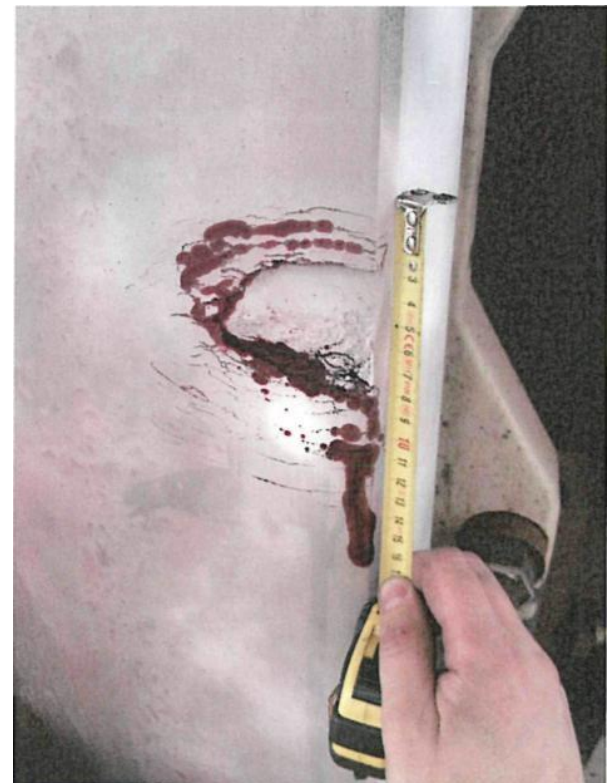
Figure 3 PT test

A test with a penetrant liquid was conducted on the surface of the ring to highlight the cracks according with SR EN ISO 3452-1.
