IN SITU STUDY OF THE DAMAGE EVOLUTION OF A ROLLING LINE CONTACT UNDER HEAVY LOAD

B.D. Onofrei, I. Muscă

*Faculty of Mechanical, Mechatronic and Management,
University "Stefan cel Mare", Suceava, Romania*

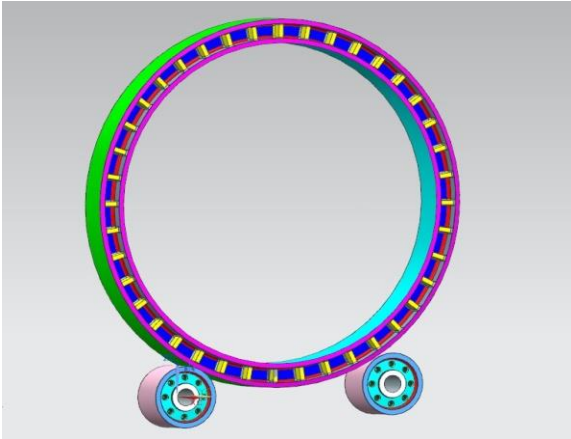
Figure 1 Assembly drawing of contact bodies

The studied situations is related to a chip dryer from wood industry. This dryer has a length of more than 30 meters with a mass of about 200 tones (fully loaded) which is supported at the ends by 2 sets of rolling contacts ring type (in diameter $d_1=7720$ mm and cast iron as material) on cylindrical roller with a diameter of $d_2=1500$ mm and cast iron as material, Fig. 1. The damage occurred on the rolling contact surface of the ring is the subject of this study.
