THE INFLUENCE OF HYDROTECHNICAL STRUCTURES ON THE MINOR RIVERBED MORPHOLOGY OF THE DANUBE, IN THE BALA BRANCH - OLD DANUBE BIFURCATION AREA

Abstract: *The morphological and hydrological phenomena that occurred in the Bala Branch - Old Danube bifurcation area led to the worsening of navigation conditions on Danube. Thus, it was necessary the execution of hydrotechnical structures allowing the navigation to be unfolded under optimum conditions on the Old Danube branch, throughout the year. In the present paper is analyzed the morphological dynamics of the Danube's minor riverbed in the mentioned area, taking into consideration the evolution of anthropogenic interventions. This analysis is based on the informational volume obtained after bathymetric, flow and velocity measurements, in the periods of preconstruction and construction of the hydrotechnical works. This study is of significant importance in achieving the correlation between the execution dynamics of hydrotechnical works and the optimization of navigation conditions as recommended by the Danube Commission, in accordance with environmental parameters.*

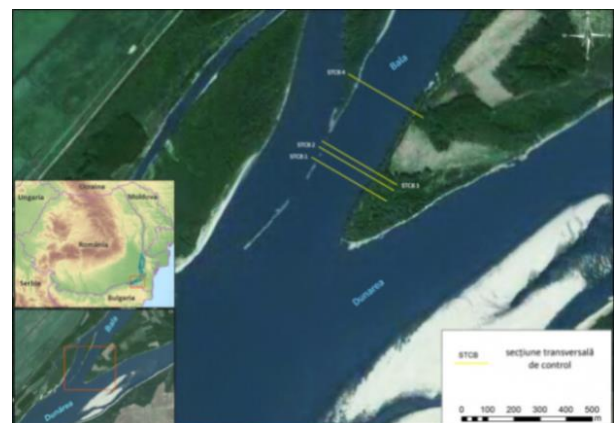
The area of study is located on the the Bala Branch - Old Danube bifurcation (Fig. 1).

Figure 1. Location of the Bala branch

In order to highlight the bottom sill influence, these monitoring sections were selected as follows: section 1, upstream the bottom sill, section 2, above the bottom sill crest, section 3, at the downstream foot of the bottom sill slope and section 4, at a distance of about 200 m downstream the bottom sill [5] (Fig.1).

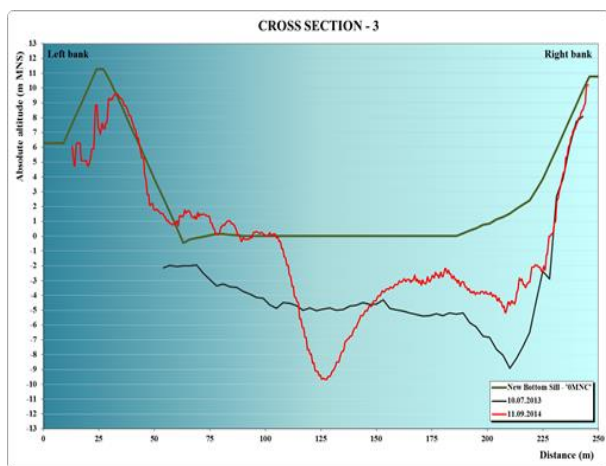
In section 3 (Fig. 5.3.) the form and depths values are strictly influenced by the evolution of the bottom sill constructions. Thus, after construction, the cavity from the right bank, which was determined after the measurements performed in 2013, at a flow rate of 7200 mc/s, has been filled with material. Also, towards the left bank, on a length of about 50 m, the bottom sill was elevated to the projected level. According to measurements performed in September 2014, at a flow rate of 7070 mc/s and a water average velocity of 2.23 m/s, on central side, it was measured a maximum depth of 9.7 m, due to the execution of the work.

Figure 5.3. Cross section 3 representing the Danube riverbed in 2013 and 2014 and the designed bottom sill (Petrescu&Deak)

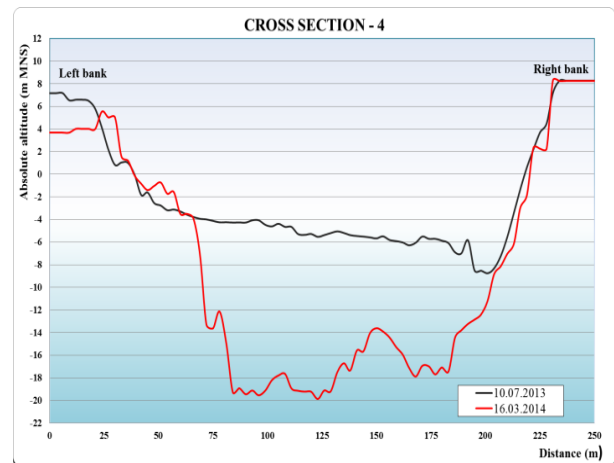
According to the measurements from March 2014 at a flow of 6970 mc/s (average water velocity of 1.26 m/s), in cross section 4, maximum depth was 19.87 m, in contrast with the maximum depth of 8.75 m registered in July 2013 at a flow of 7200 mc/s (average water velocity of 1.38 m/s) (Fig. 5.4). Also, the riverbed form was deepened by an average of about 10 m on the central part, on a length of approximately 100 m.

The scour hole determined in July 2013, appeared on a length of approximately 100 m, on the central side and had an average depth of about 10 m from the baseline.

Figure 5.4. Cross section 4 representing the Danube riverbed in 2013 and 2014 (Petrescu&Deak)
